SITE INVESTIGATION
FACTUAL REPORT

Report No:	SI-571866
Client:	Crawford Claims Management
Site:	Milldale, South Street, Woodhurst Cambridgeshire
Client Ref:	SU2205096
Date of Visit:	24/02/2023

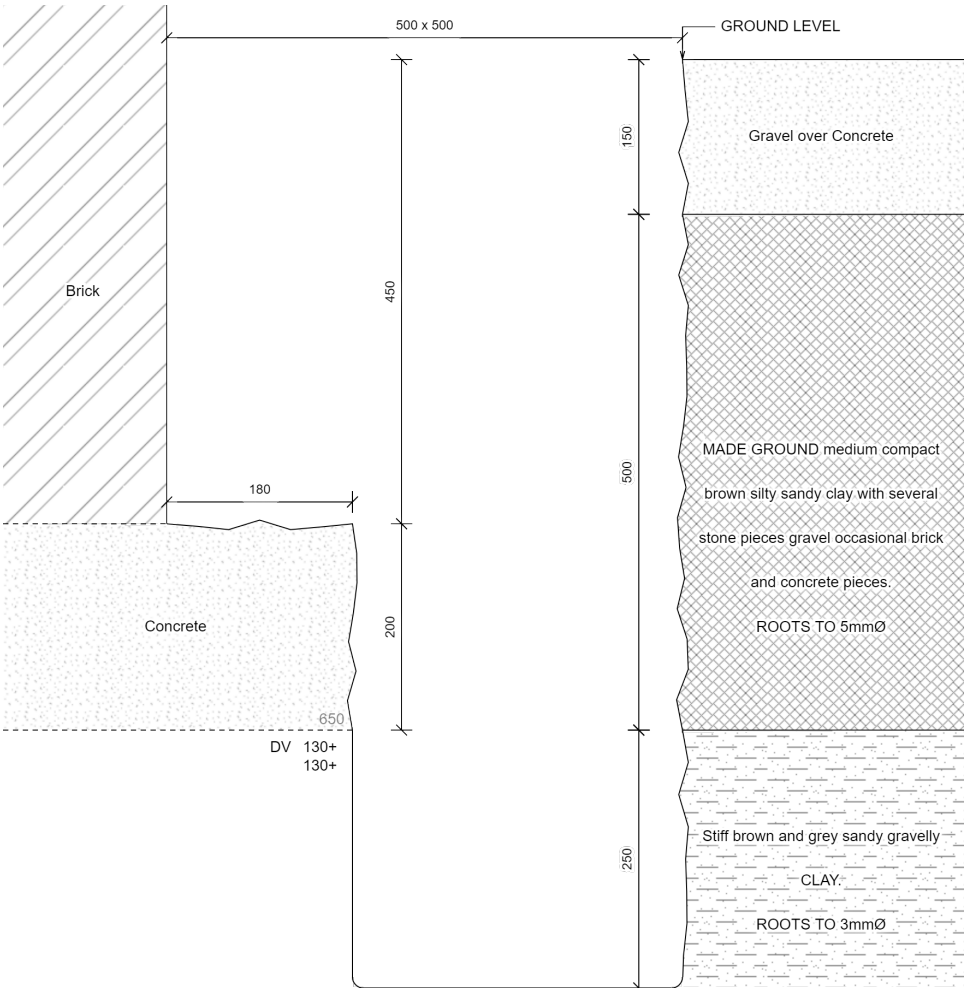
TEST REPORT: **Trial Pit**

Curved steel pin driven 200mm under concrete foundation at 650mm below ground level.

Sub Sample	Species Identified		Root Diameter	Starch
TP1:				
USF	*Fraxinus* spp.	1	1.5 mm	Abundant
BH1:				
to 1.5m	*Fraxinus* spp.	2	1 mm	Moderate

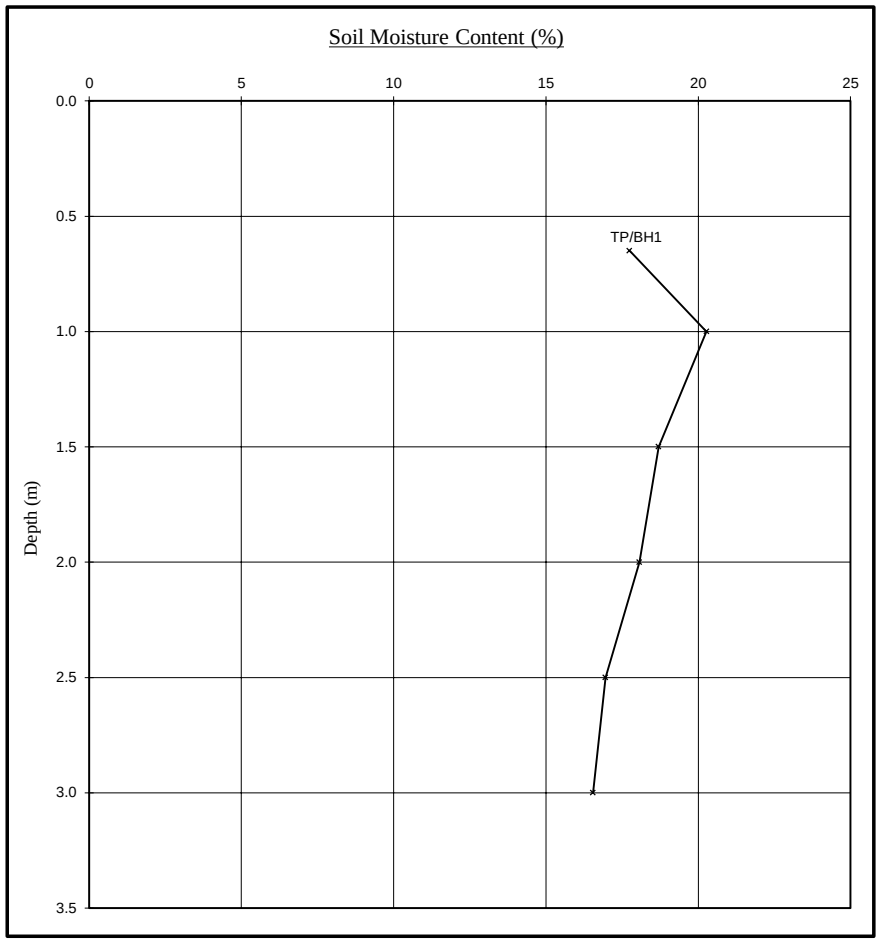
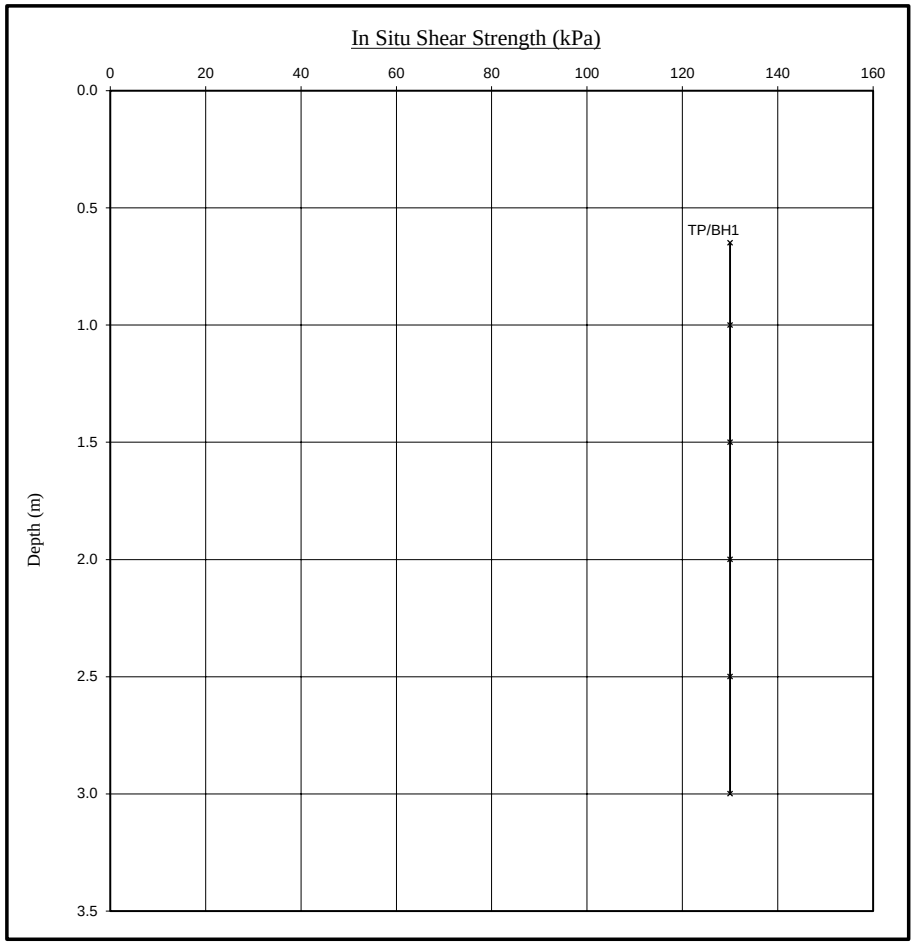
Moisture Content Profiles

Shear Strength Profiles
