CONDITION SURVEY AND NOTES ON REPAIRS

Project: Broom Lodge, Hemingford Grey

Drawing Title: Window Schedule WG.7 and DG.3

LBC CONDITIONS DISCHARGE

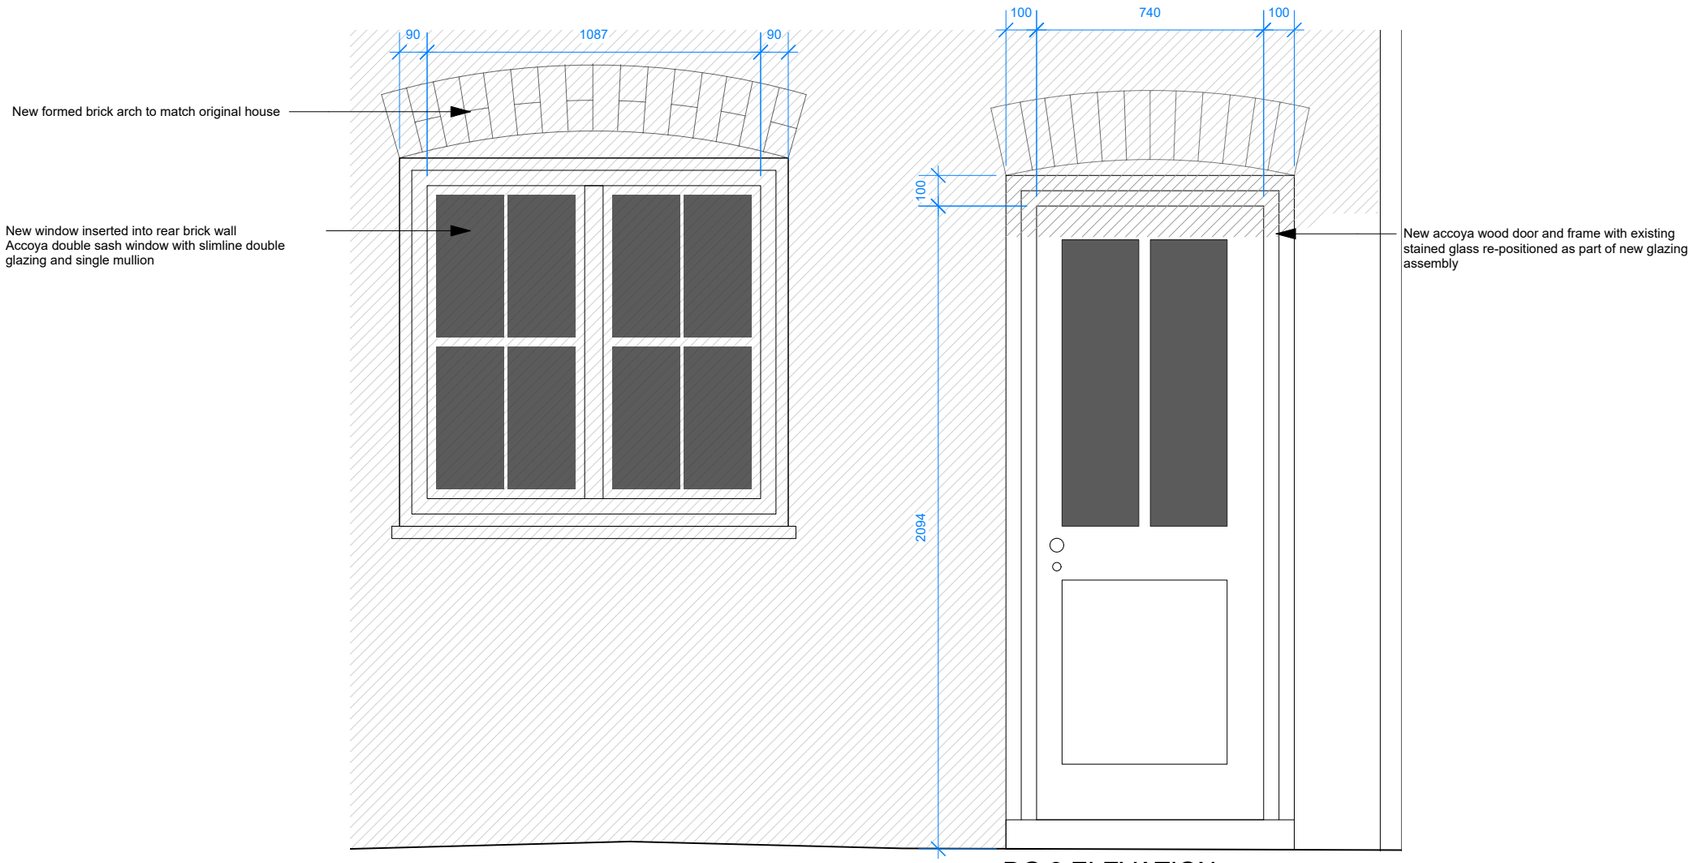
ARRANGEMENT FOR WINDOWS/DOORS:
- WG.7
- DG.3

DG.3 is an existing timber part-glazed rear door that has suffered from multiple alterations and is in poor condition. The door will be replaced with a new accoya wood door with the original stained glass to be fitted as part of a double glazed assembly within the new door.

In this location, replacing the existing part glazed door constitutes an acceptable loss of historic fabric, given this is in the Victorian extension, and the rather ordinary character of the door to be replaced.
