SI-783240

Crack and Level Monitoring

Address: 1 Wheatstone Road, Huntingdon, Cambridgeshire, PE29 1DE

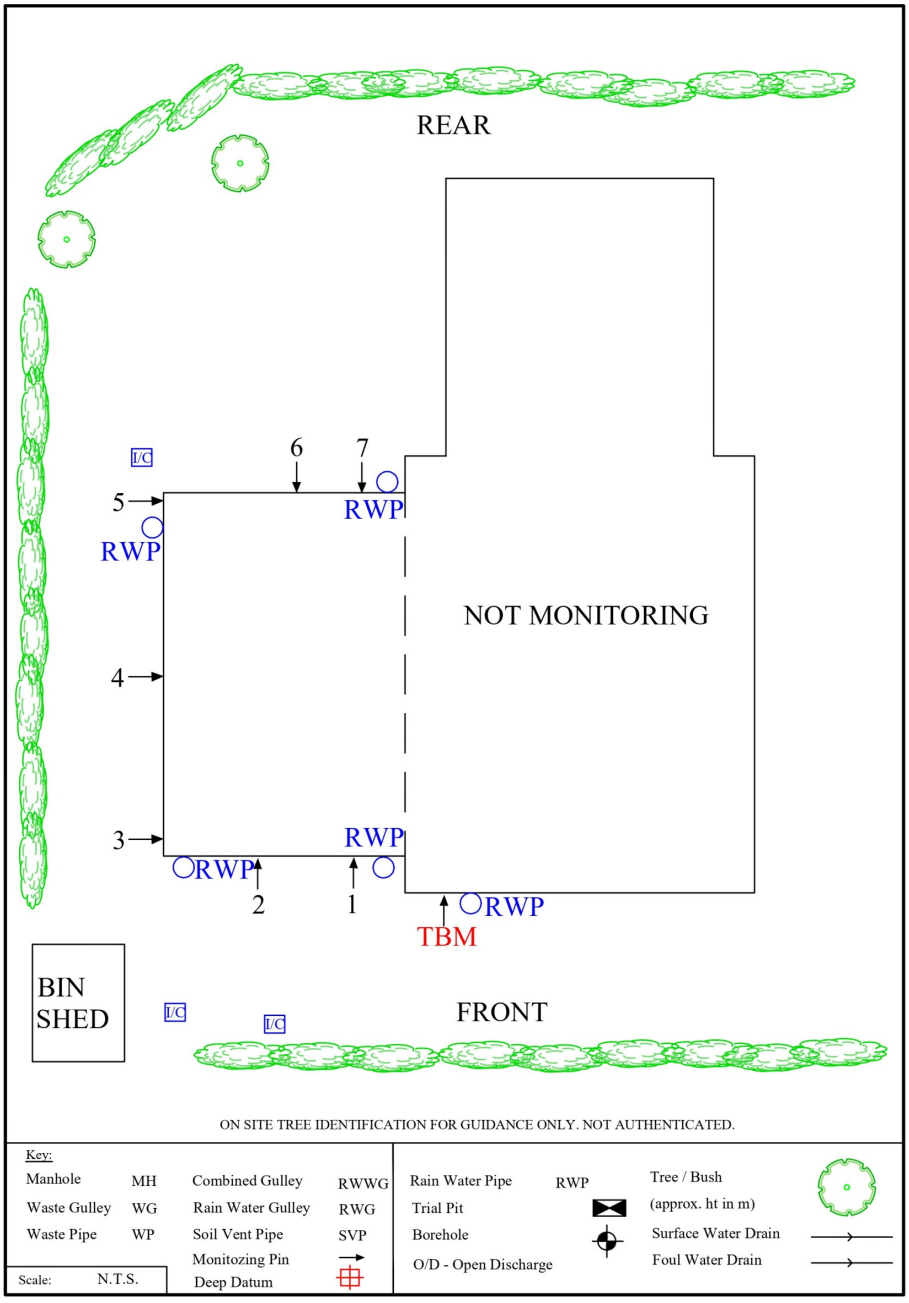
Site Plan

REAR
6
7
5
RWP
RWP
NOT MONITORING
4
3
RWP
RWP
2
1
RWP
TBM
BIN SHED
FRONT
I/C
I/C
I/C
ON SITE TREE IDENTIFICATION FOR GUIDANCE ONLY. NOT AUTHENTICATED.
Key:
Manhole MH
Waste Gulley WG
Waste Pipe WP
Combined Gulley RWWG
Rain Water Gulley RWG
Soil Vent Pipe SVP
Monitozing Pin
Deep Datum
Rain Water Pipe RWP
Trial Pit
Borehole
O/D - Open Discharge
Tree / Bush
(approx. ht in m)
Surface Water Drain
Foul Water Drain
Scale: N.T.S.

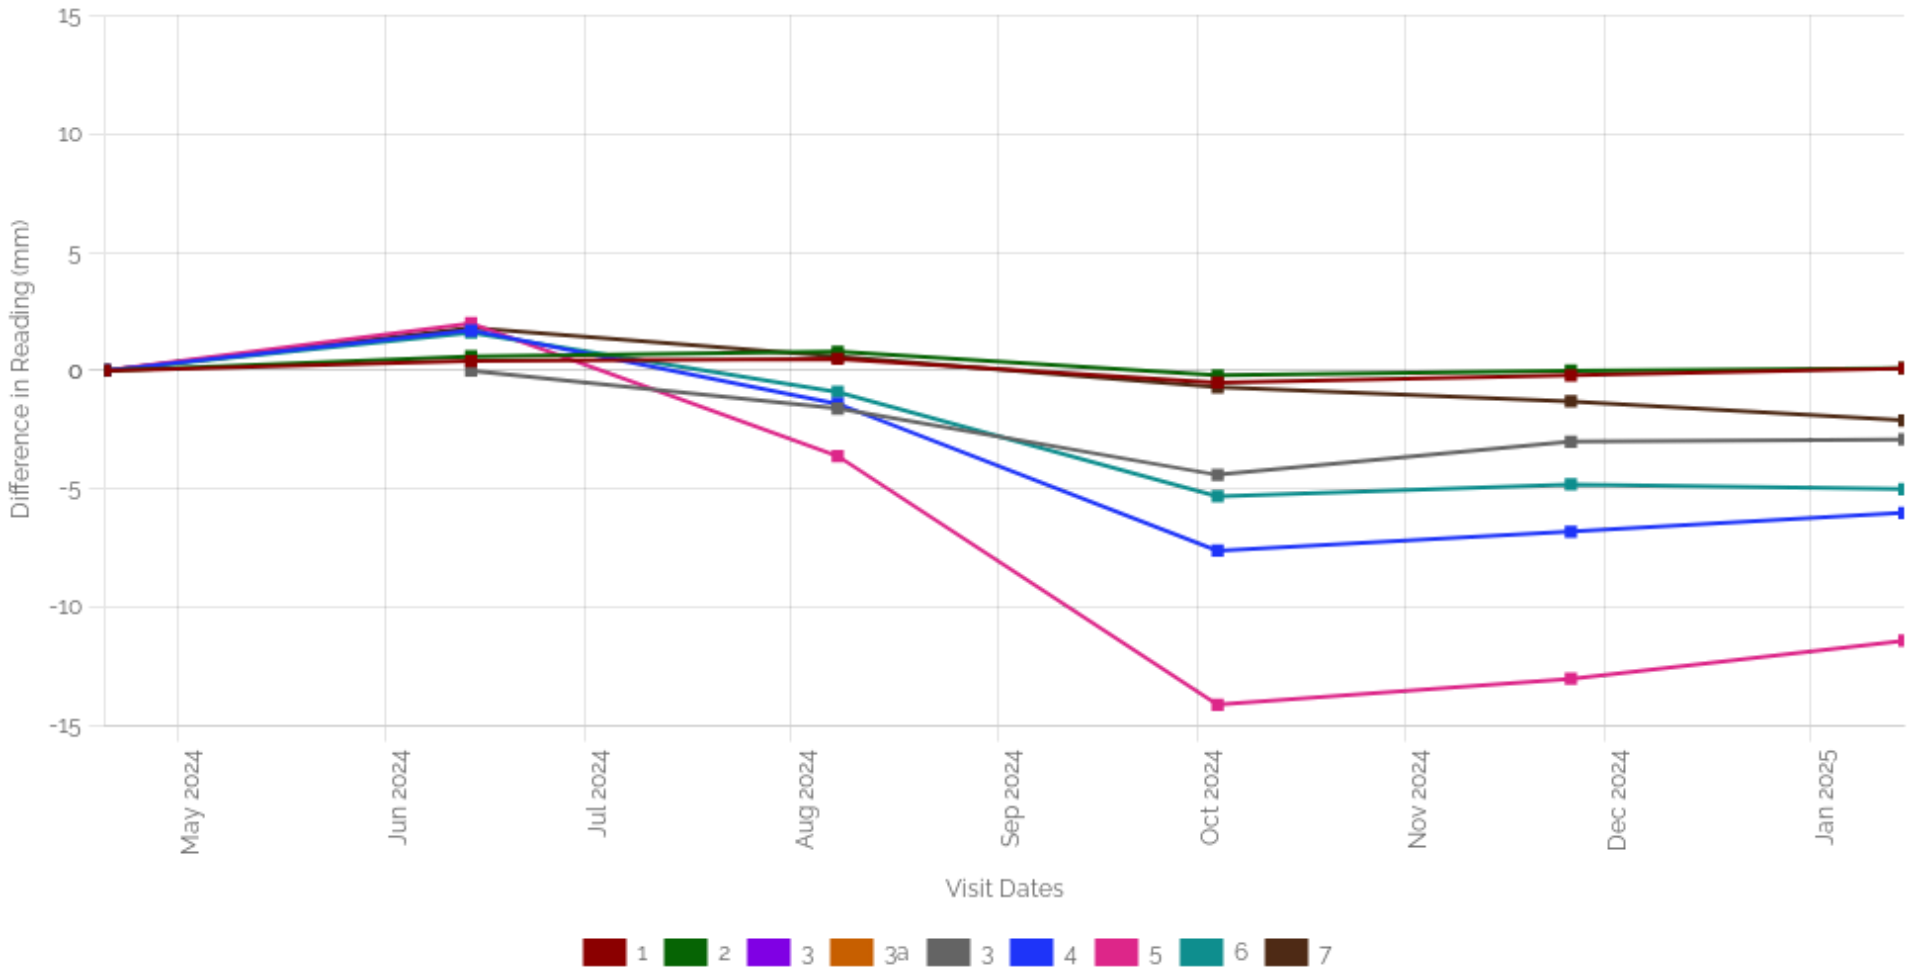
Level Readings Chart (Points 1 - 7)

Visit 1	Visit 2	Visit 3	Visit 4	Visit 5	Visit 6	Visit 7	Visit 8
	19/04/24	13/06/24	07/08/24	03/10/24	25/11/24	14/01/25		
1	0	+0.4	+0.5	-0.5	-0.2	+0.1		
2	0	+0.6	+0.8	-0.2	0	+0.1		
3	0							
3a								
3		0	-1.6	-4.4	-3	-2.9		
4	0	+1.7	-1.4	-7.6	-6.8	-6		
5	0	+2	-3.6	-14.1	-13	-11.4		
6	0	+1.6	-0.9	-5.3	-4.8	-5

Visit 1	Visit 2	Visit 3	Visit 4	Visit 5	Visit 6	Visit 7	Visit 8
	19/04/24	13/06/24	07/08/24	03/10/24	25/11/24	14/01/25		
7	0	+1.8	+0.6	-0.7	-1.3	-2.1

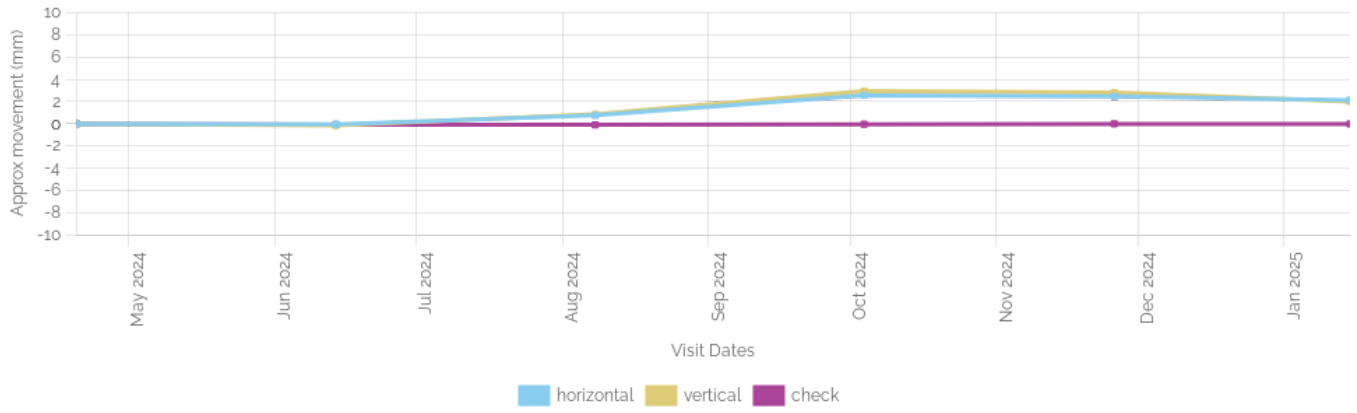
External rear elevation below left ground floor window

Visit 1	Visit 2	Visit 3	Visit 4	Visit 5	Visit 6	Visit 7	Visit 8
	19/04/24	13/06/24	07/08/24	03/10/24	25/11/24	14/01/25		
H	0	-0.04	0.76	2.56	2.45	2.13		
V	0	-0.14	0.86	2.94	2.8	2		
C	0	-0.07	-0.09	-0.03	0	-0.01

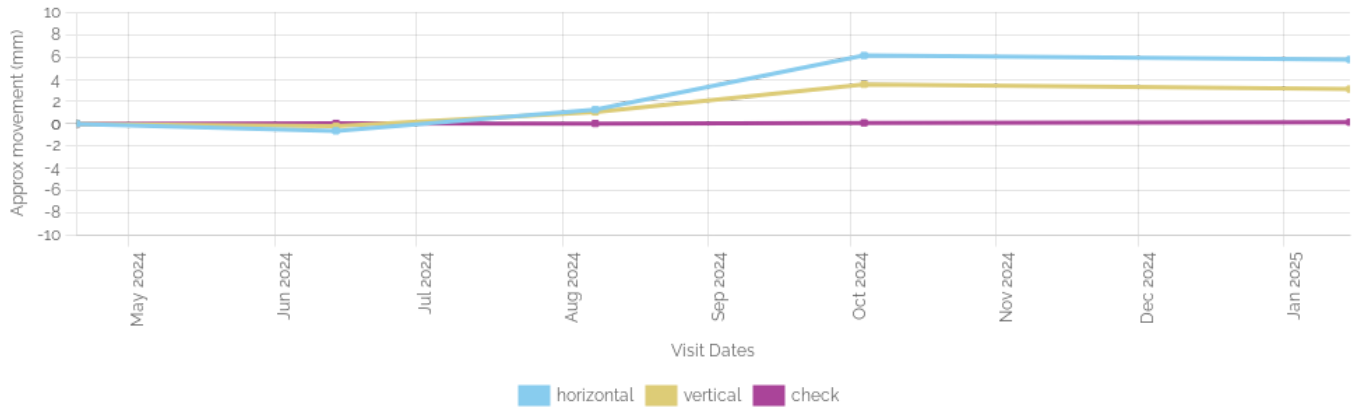
External rear elevation above left ground floor window ladders needed

Visit 1	Visit 2	Visit 3	Visit 4	Visit 5	Visit 6	Visit 7	Visit 8
	19/04/24	13/06/24	07/08/24	03/10/24	25/11/24	14/01/25		
H	0	-0.63	1.27	6.13		5.76		
V	0	-0.2	1.06	3.54		3.12		
C	0	0.04	0.03	0.09		0.15

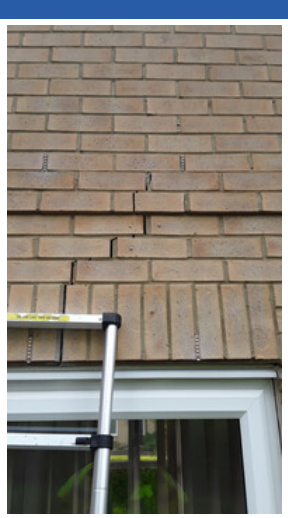
External rear elevation above left ground floor window ladders needed - Visit #6

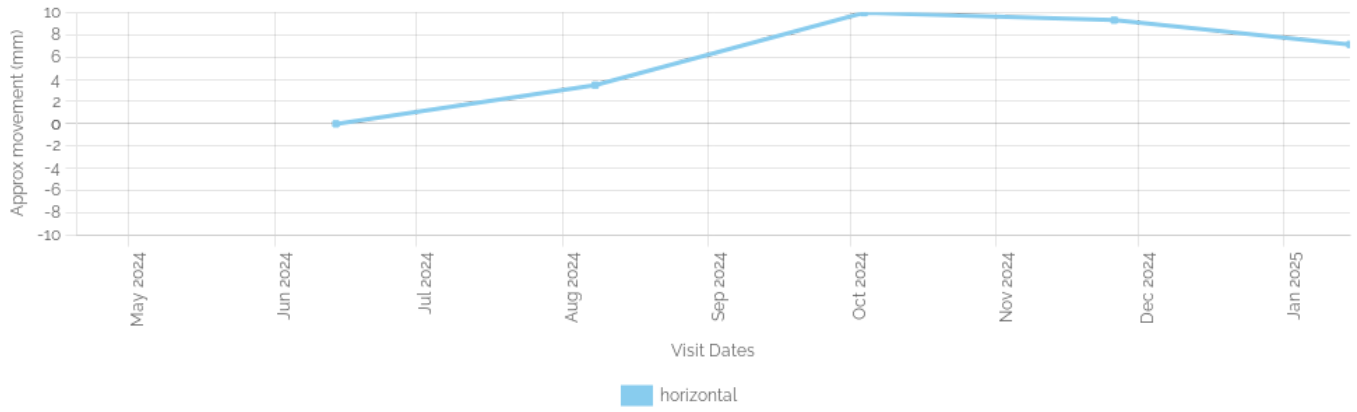
External - rear elevation between ground floor windows, DPC level

Visit 1	Visit 2	Visit 3	Visit 4	Visit 5	Visit 6	Visit 7	Visit 8
	19/04/24	13/06/24	07/08/24	03/10/24	25/11/24	14/01/25		
H		0	3.47	9.96	9.29	7.12

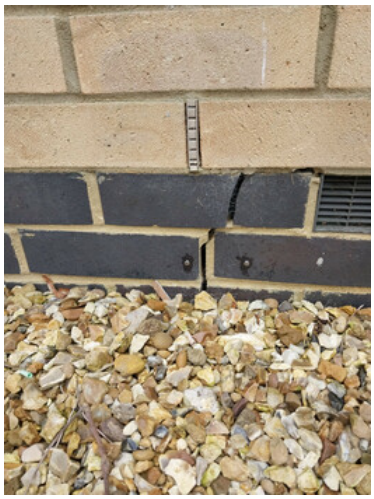
External - rear elevation between ground floor windows, DPC level - Visit #6
