Property Risk Inspection
LIMITED

PRELIMINARY ARBORICULTURAL REPORT

Risk Address: Barn Hurst Church Street, Alwalton, Peterborough PE7 3UU

Council Name: Huntingdonshire
PRI Ref: 370529
Arborist: [redacted]
Survey Date: 02-09-2026

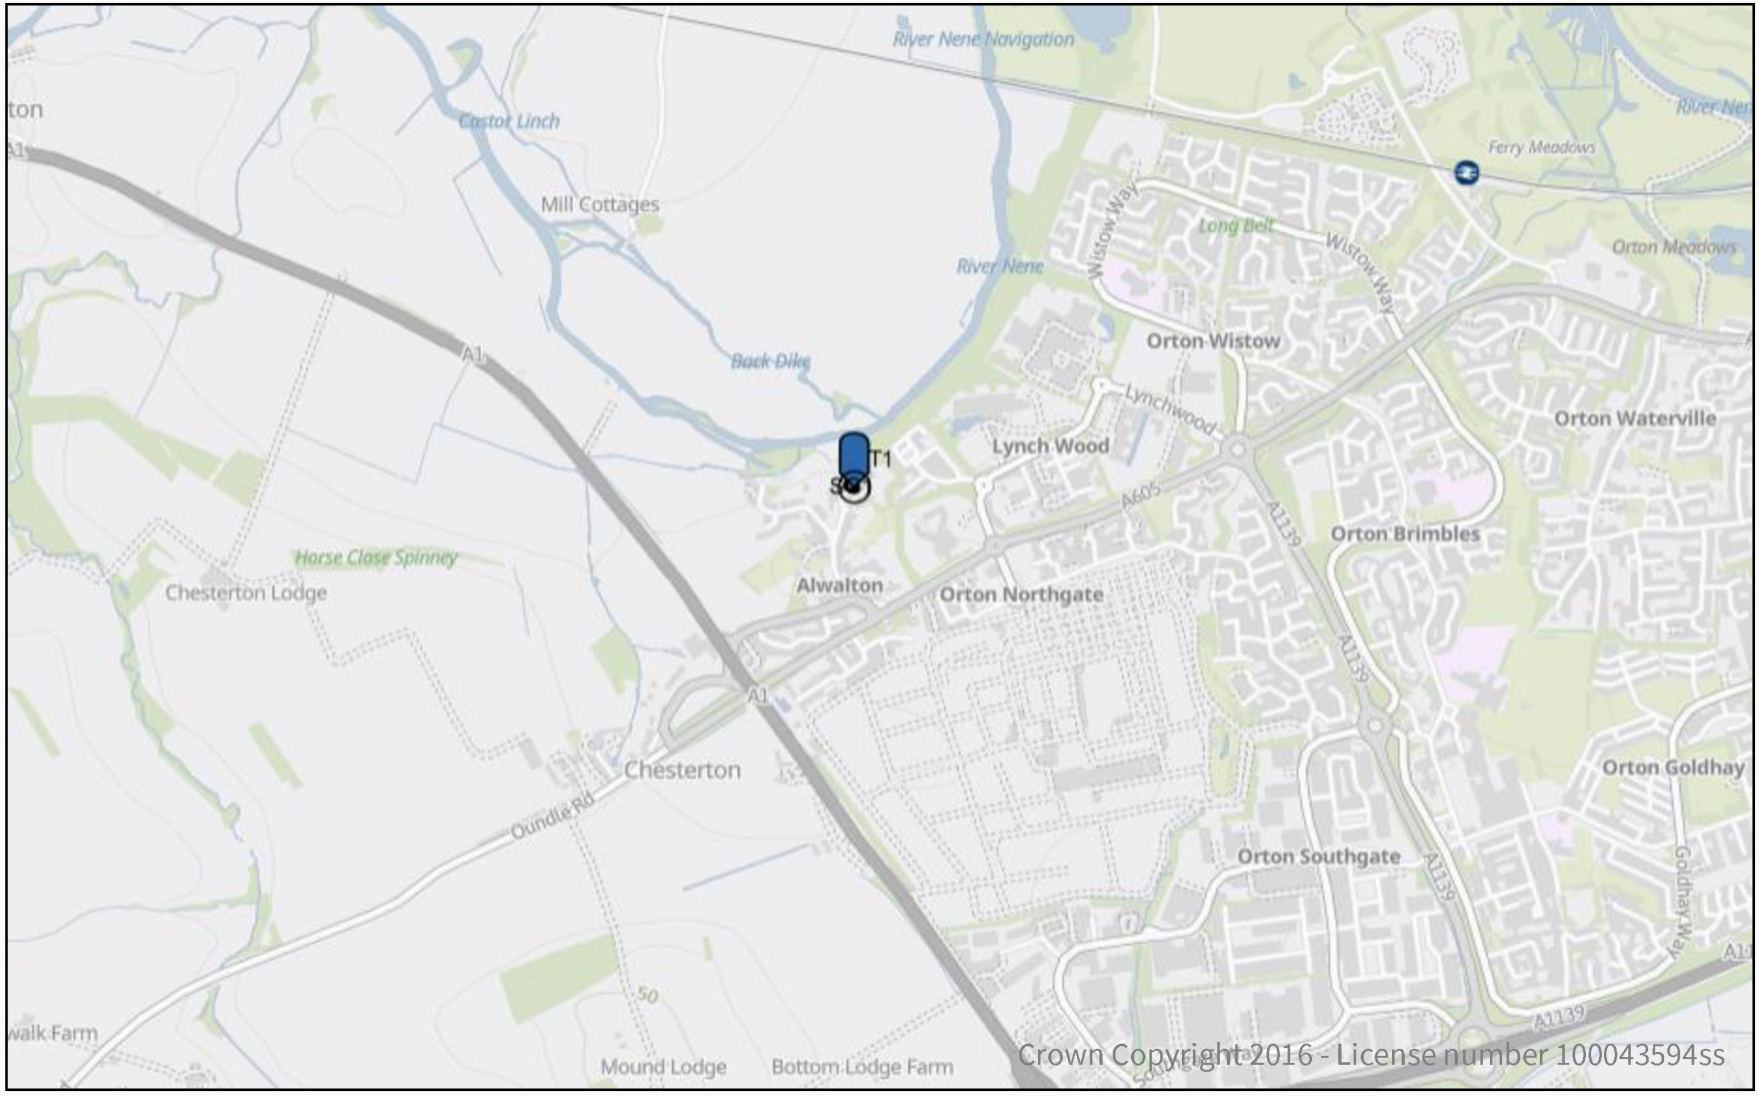
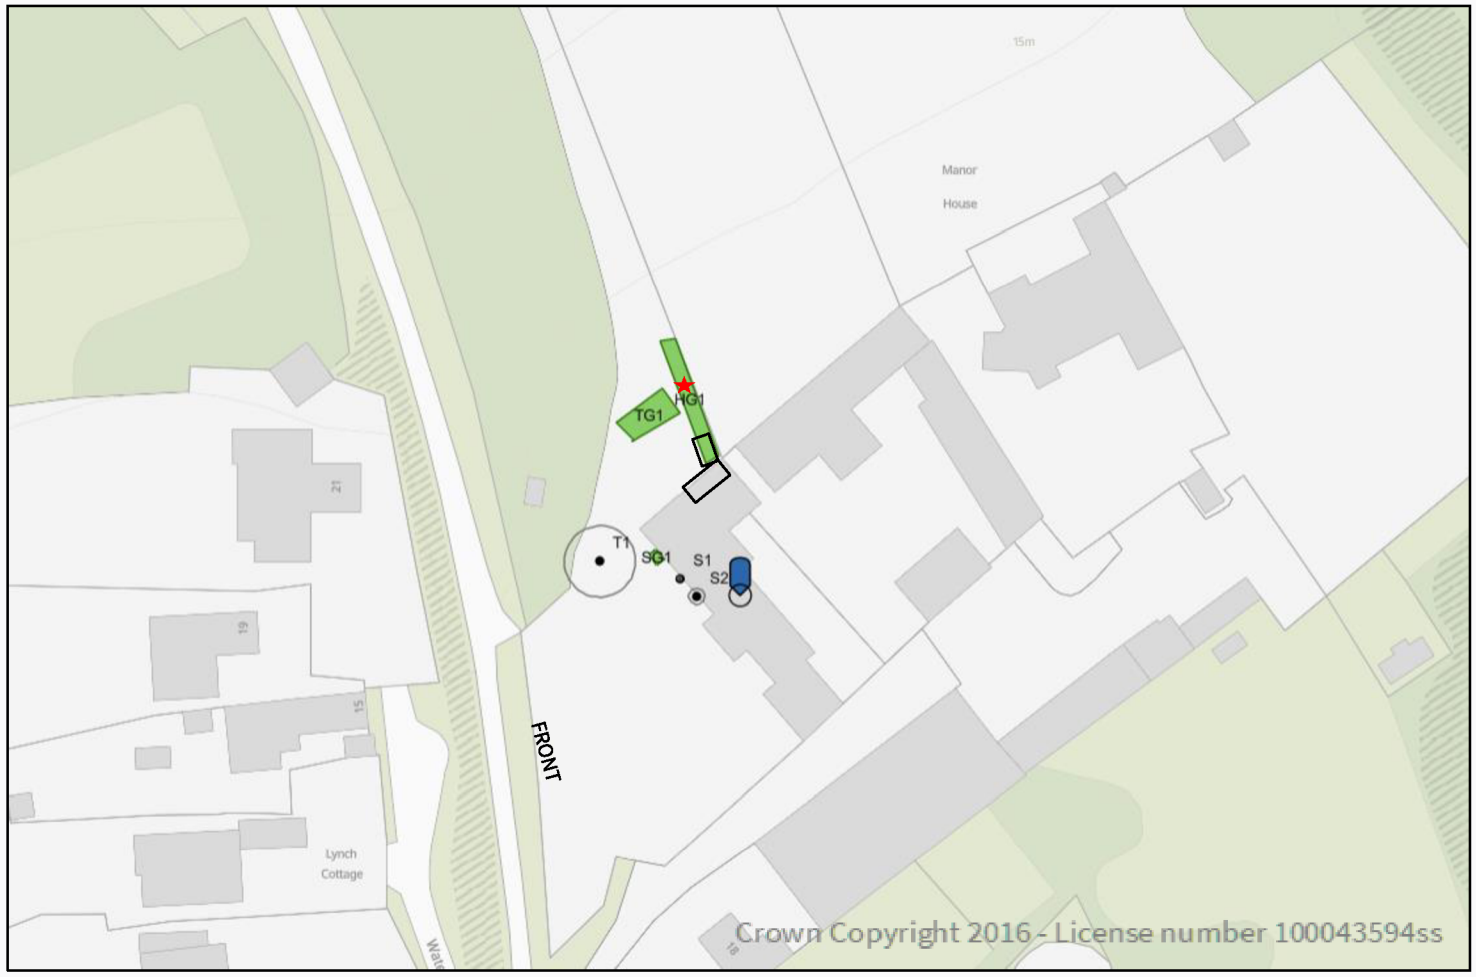
7.0 APPENDIX 2: SITE PLAN

Tree No:	Species	Works Required	CA	TPO	Ownership
HG1	Mixed species group	Remove all vegetation within 4m of property.	Yes	No	PH
