Design & Heritage Statement

Replacement of two timber windows to end gable

6 THE SQUARE, WARESLEY, SANDY SG19 3BT

November 2026

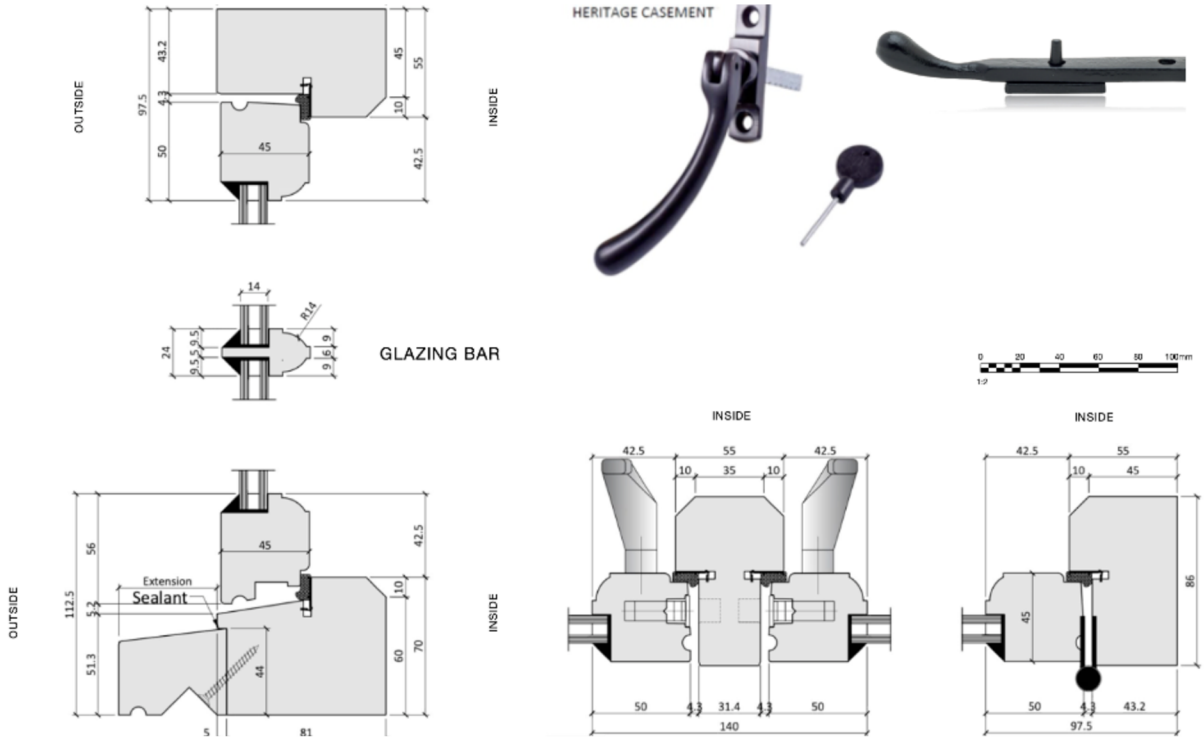
Figure 10. Details of proposed replacement windows (not to scale)

6.1 The application seeks consent to replace the two existing windows with high-quality traditional flush-fitting timber casements appropriately detailed to reflect the other windows within the property and to retain a cohesive and sensitive appearance.

6.2 Both replacement windows would be the same proportions as the existing but with two true through solid horizontal glazing bars. The profile and detailing of the frames would reflect the other timber casement windows installed within the cottage and would be painted white using a suitable micro-porous water based paint.

6.3 Slimline double glazing (4/6/4mm) is proposed to improve thermal performance but this would be sealed externally using glazing compound to retain a traditional appearance.

6.4 The proposed black bulb-end handle and casement stay would protect the character and charm of the listed building and would retain a consistency with the other windows.
